**ENVIRONMENTAL QUALITY MONITORING REPORT
FOR MANUFACTURING OF METALLIC COATED
STEEL STRIP AND PAINTED STEEL STRIP OF
JFE MYANMAR COATED STEEL CO., LTD.
IN THILAWA SPECIAL ECONOMIC ZONE B
(OPERATION STAGE)**

December 2024
Myanmar Koei International Ltd.

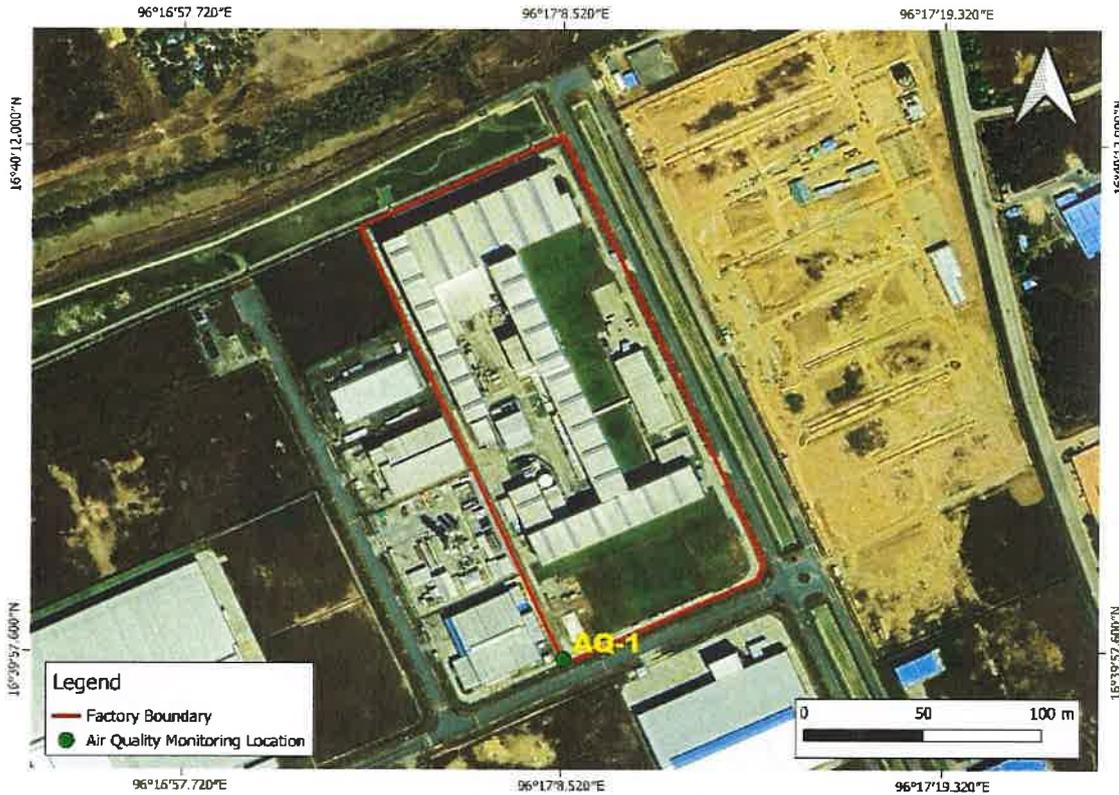
Figure 2.1-1 Location of Ambient Air Quality Monitoring Point

The location of ambient air quality monitoring point is shown in Table 2.1-2 and Figure 2.1-1.

Survey Point	Coordinates	Description of Survey Point
AQ-1	N: 16°39'57.38", E: 96°17'8.57"	South of the JFE MYANMAR Coated Steel factory compound, which is nearest place to the sensitive receptors

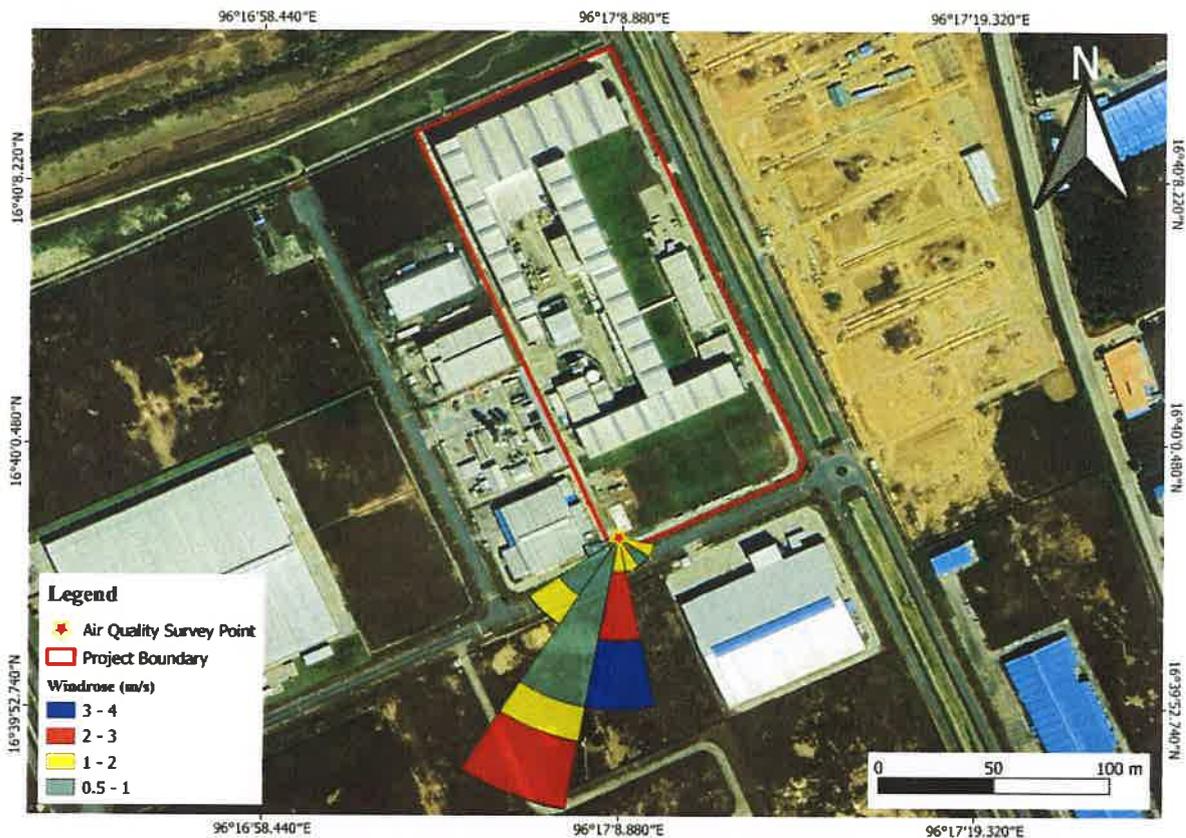
Figure 2.1-3 Wind Status at AQ-1

Wind direction and wind speed were measured at AQ-1. Hourly average values of measured wind direction and wind speed data are described in Appendix-1. Frequency of wind direction at AQ-1 and its wind rose diagram are described in Figure 2.1-3 and Figure 2.1-4. According to the wind rose analysis, the prevailing wind direction during monitoring was South-Southwest (SSW) and the least frequency wind direction were East-Southeast (ESE), South-Southeast (SSE) and West-Southwest (WSW). During the monitoring period, while the maximum wind speed was 3.1 m/s, the average speed is 1.23 m/s. The calm wind is 20.83 %, whereas the calm wind is defined below 0.5 m/s. As the average wind speed is higher than the defined calm wind, it is assumed that the wind was light air during the monitoring period.

According to the summary of wind direction at AQ-1, most of the prominent wind were blowing from Southwest (SW) quadrants.

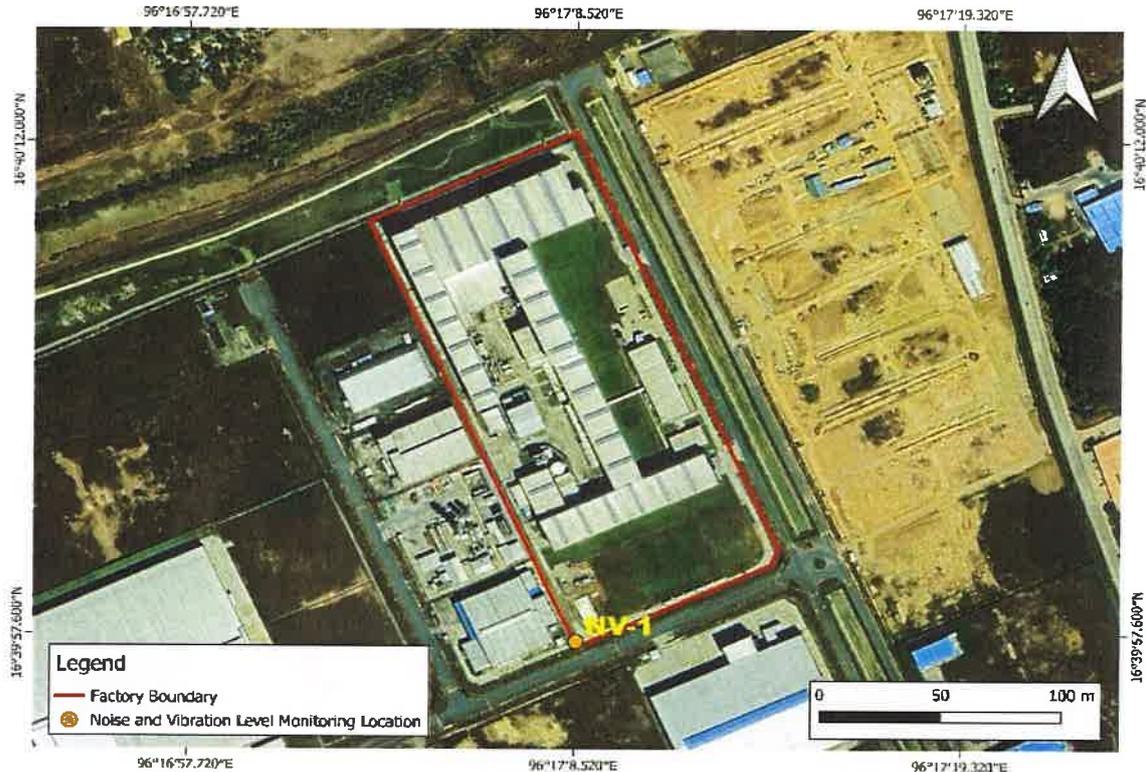
Figure 2.2-1 Location of Outdoor Noise and Vibration Level Monitoring Point

The location of outdoor noise and vibration level points is shown in Table 2.2-3. The detail of survey point is described below. The location of the outdoor noise and vibration monitoring points is shown in Figure 2.2-1.

Survey Point	Coordinates	Description of Monitoring Point
NV-1	N: 16°39'57.39", E: 96°17'8.56"	South of the factory compound

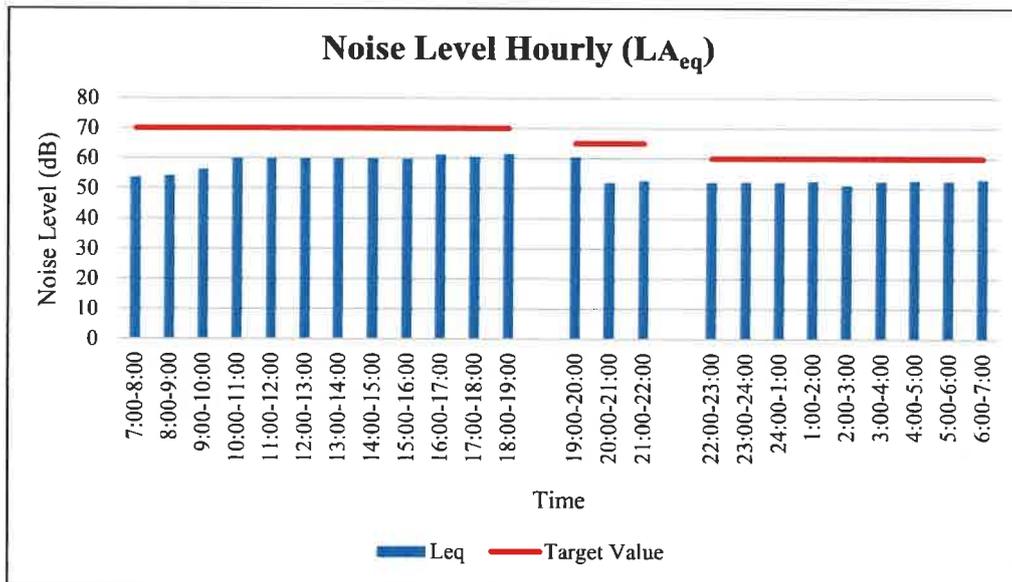
Figure 2.2-3 Results of Outdoor Noise Levels (L_{Aeq}) Monitoring at NV-1

Date	Time	Hourly Result L_{Aeq} (dB)	Interval Result L_{Aeq} (dB)	Target Value L_{Aeq} (dB)
3 December 2024 – 4 December 2024	7:00-8:00	54	59	70
	8:00-9:00	54		
	9:00-10:00	56		
	10:00-11:00	60		
	11:00-12:00	60		
	12:00-13:00	60		
	13:00-14:00	60		
	14:00-15:00	60		
	15:00-16:00	60		
	16:00-17:00	61		
	17:00-18:00	61		
	18:00-19:00	61		
	19:00-20:00	60	57	65
	20:00-21:00	52		
	21:00-22:00	53		
	22:00-23:00	52	52	60
	23:00-24:00	52		
	24:00-1:00	52		
	1:00-2:00	52		
	2:00-3:00	51		
	3:00-4:00	52		
	4:00-5:00	53		
	5:00-6:00	52		
	6:00-7:00	53

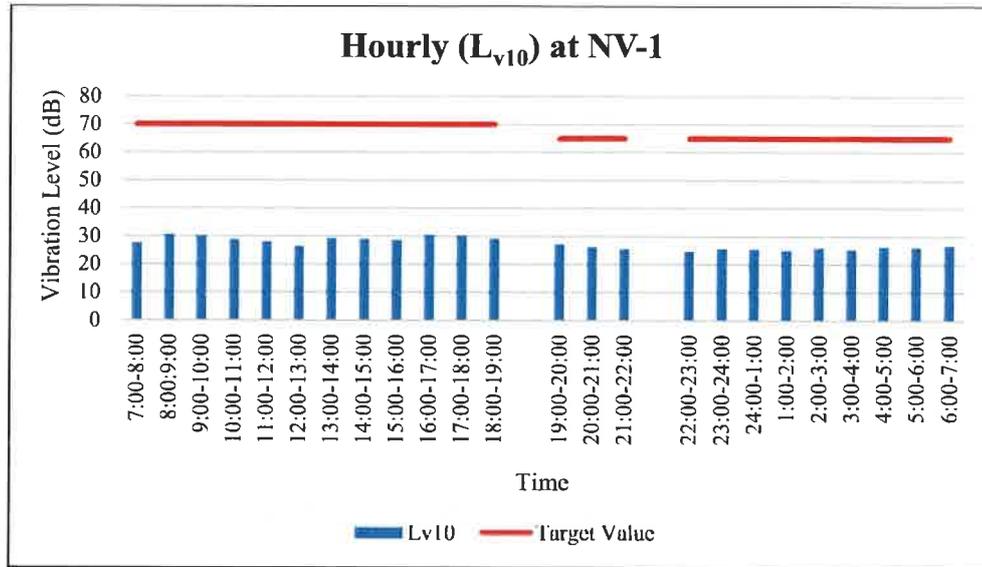
Figure 2.2-4 Results of Outdoor Vibration Level (L_{v10}) Monitoring at NV-1

Outdoor vibration monitoring results are separated daytime (7:00 AM to 7:00 PM), evening time (7:00 PM to 10:00 PM) and night time (10:00 PM to 7:00 AM) time frames respectively for NV-1. Outdoor vibration measurement was carried out for one location on a 24-hour basis. The results of outdoor vibration level (L_{v10}) monitoring at NV-1 are shown in Table 2.2-6. Results of hourly outdoor vibration level monitoring for NV-1 are summarized in Table 2.2-7 and Figure 2.2-4 shows the results of vibration level (L_{v10}) at NV-1. By comparing with the target vibration level in operation stage in final EIA report for JFE MYANMAR Coated Steel Co., Ltd. (referred to Section 2.2.4 Vibration, Table 2.2-14), all results were under the target values.

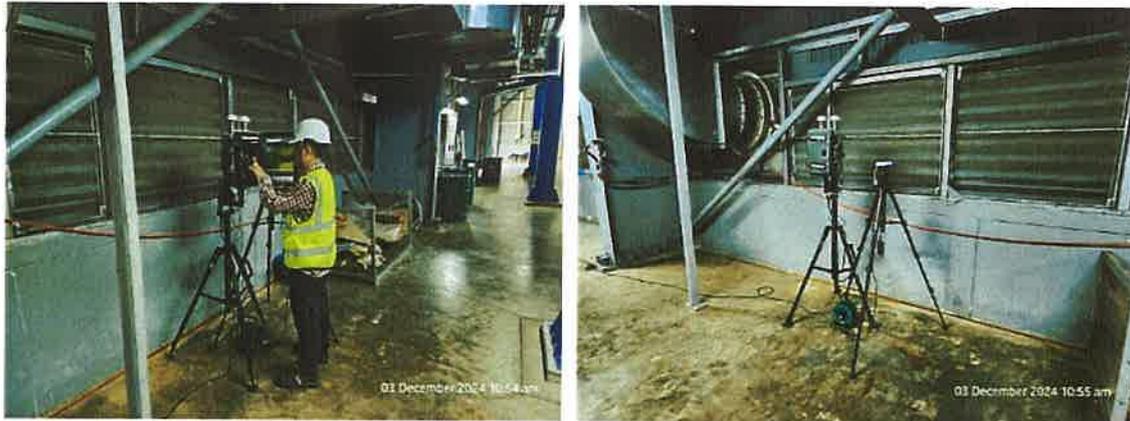
Figure 2.3-2 Status of Indoor Air Quality Monitoring at Coater-A

Survey of indoor air quality (PM_{2.5} and PM₁₀) was conducted by referring to the recommendation of the United States Environmental Protection Agency (U.S. EPA). The Haz-Scanner EPAS was used to collect indoor air pollutants. The EPAS measures automatically every one minute and directly reads and records onsite for PM_{2.5} and PM₁₀.

Survey of volatile organic compound (VOC) was conducted by using Aeroqual-500 series with VOC sensor (0-25 ppm range). VOC sensor (0-25 ppm range) was chosen because the measurement was conducted in indoor production area. The detailed information of VOC sensors with different ranges are described in the Table 2.3-3. Aeroqual-500 series equipment was set up and placed at height of 1.5m which is the breathing level relative to the average human height. The equipment measures automatically every five minutes and the data was recorded and logged into PC on real time basis.

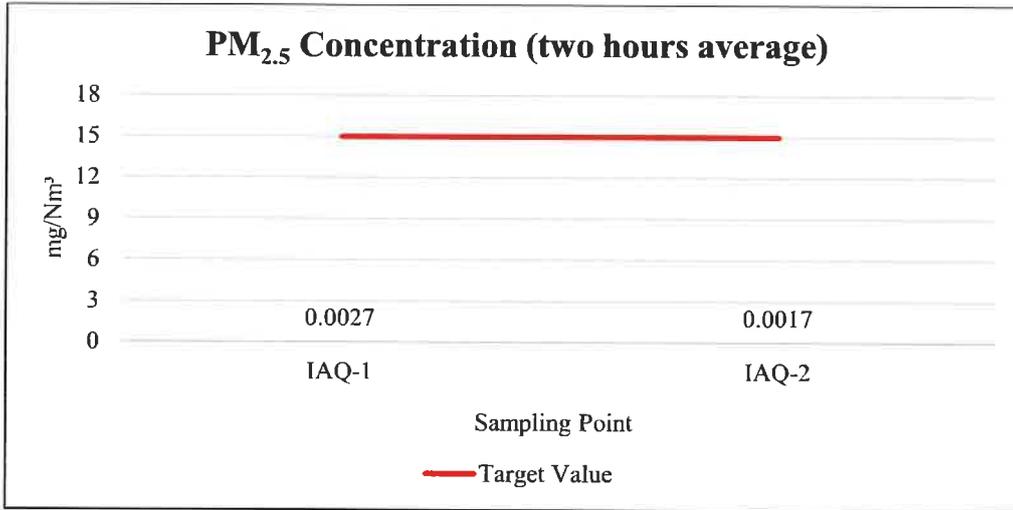
Figure 2.3-4 Results of Indoor Air Quality Monitoring (PM_{2.5})

Date	Time	Survey Point	Survey Location	PM _{2.5}	PM ₁₀
				(mg/m ³)	(mg/m ³)
3 December, 2024	10:30 ~ 12:29	IAQ-1	Coater-A	0.0027	0.0092
3 December, 2024	13:00 ~ 14:59	IAQ-2	Coater-B	0.0017	0.0040
Target Value				15	15

- 1) The value of PM_{2.5} and PM₁₀ are two hours average. All results are lower than the target value.
- 2) The value of PM_{2.5} and PM₁₀ were converted to mg/m³ from µg/m³ at 25°C, 1 atm condition
- 3) Target value is referred to the National Institute for Occupational Safety and Health (NIOSH), Centers for Disease Control and Prevention (CDC), U.S.

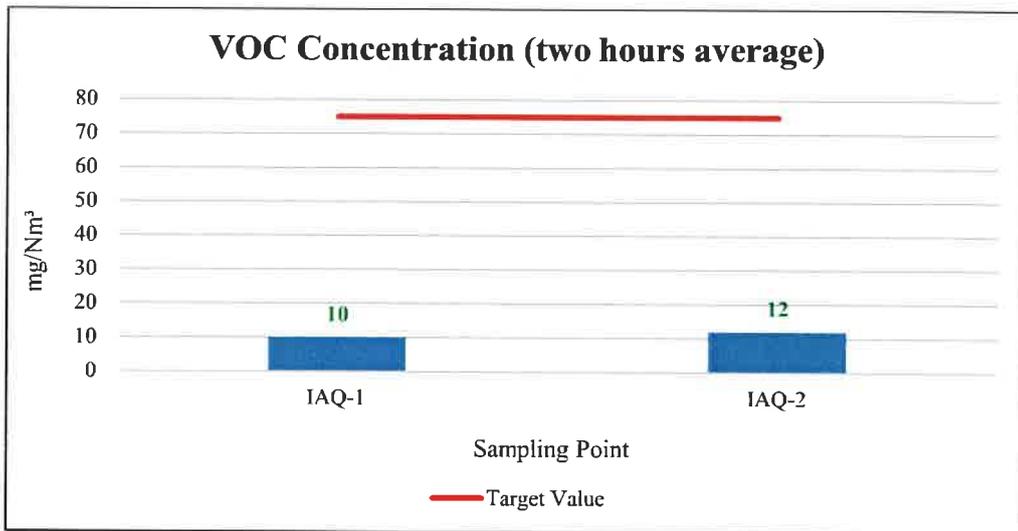
Figure 2.3-6 Results of Indoor Air Quality Monitoring (VOC)

Date	Time	Survey Point	Survey Location	Relative Humidity	Temperature	VOC
				(%)	(°C)	(mg/Nm ³)
3 December, 2024	20:15 ~ 22:14	IAQ-1	Coater-A	72.1	30.8	10
3 December, 2024	18:00 ~ 19:59	IAQ-2	Coater-B	57.7	34.4	12
Target Value				-	-	75

- 1) The value of VOC is two hours average. All results are lower than the target value.
 - 2) The value of VOC was converted to mg/Nm³ from ppm.
 - 3) Target value is referred to the final EIA report for JFE MYANMAR Coated Steel Co., Ltd.
- Source: Myanmar Koei International Ltd.

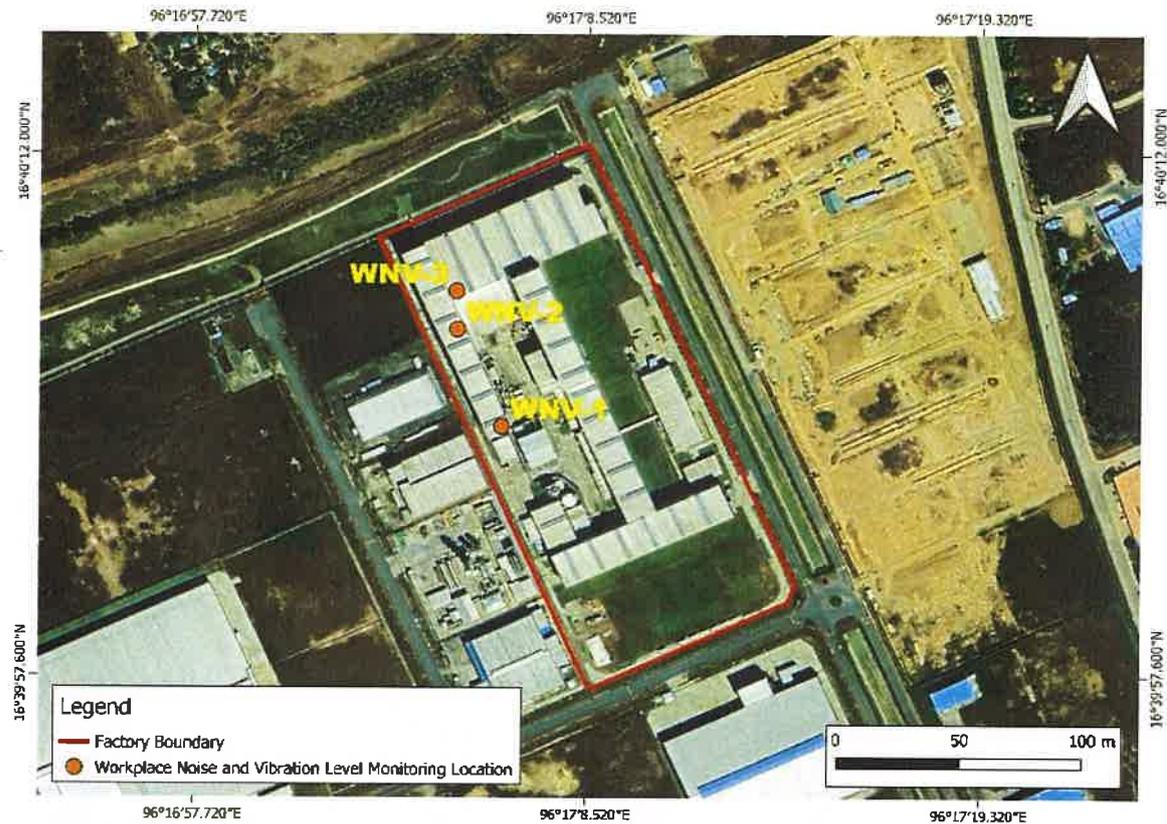
Figure 2.4-1 Location of Workplace Noise and Vibration Level Monitoring Points

Survey Point	Coordinates	Description of Monitoring Point
WNV-1	N: 16°40'4.50", E: 96° 17'6.14"	Near Coater-A which is inside the JFE MYANMAR Coated Steel factory
WNV-2	N: 16°40'7.17", E: 96° 17'4.90"	Entry Accumulator which is inside the JFE MYANMAR Coated Steel factory
WNV-3	N: 16°40'8.22", E: 96° 17'4.87"	Near Quality Control Laboratory which is inside the JFE MYANMAR Coated Steel factory

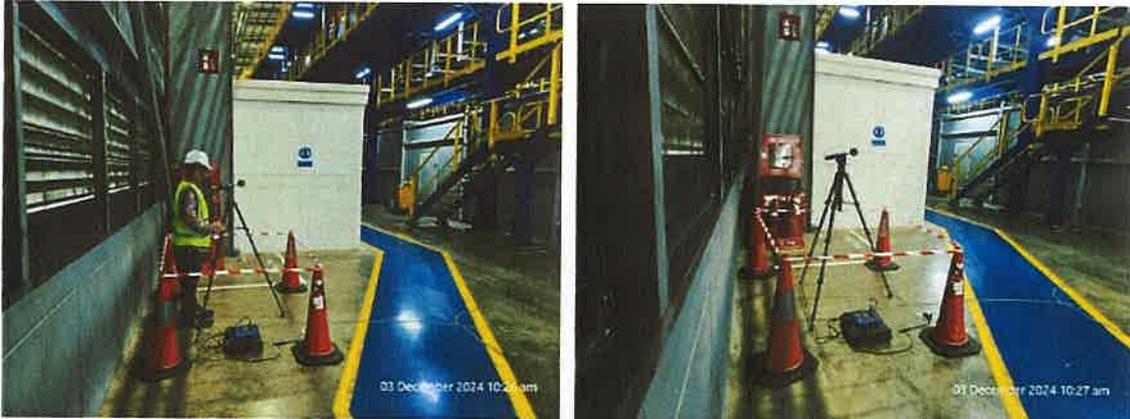
Figure 2.4-2 Status of Workplace Noise and Vibration Level Monitoring Near Coater-A

Workplace noise level was measured by "Rion NL-43 sound level meter" and automatically recorded every 10 minutes on a memory card. Workplace vibration level meter, VM-55 (Rion Co. Ltd., Japan),

accompanied by a 3-axis accelerometer PV-83C (Rion Co. Ltd.), was placed on solid soil ground. Vertical vibration (Z axis), L_{v10} , was measured every 10 minutes within the adaptable range of (10-70) dB at INV-1, (10-70) dB at INV-2 and (10-70) dB at INV-3 recorded on a memory card.

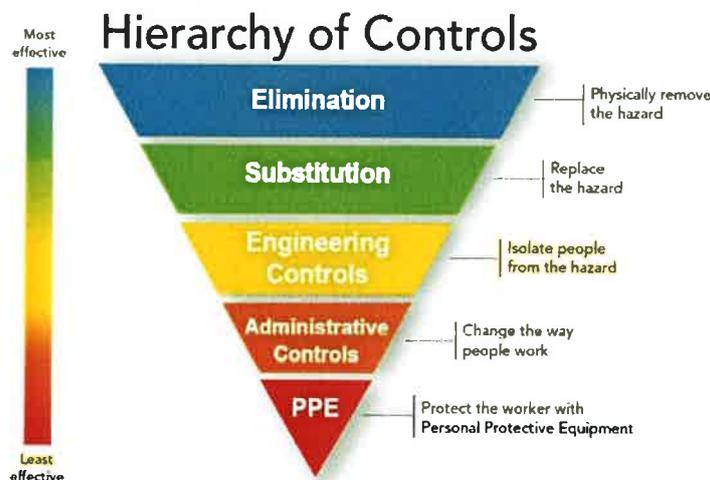
Figure 2.4-9 Hierarchy of Controls

The hierarchy of control can be used to determine how to implement feasible and effective controls. This approach groups actions by their likely effectiveness in reducing or removing the noise hazard.

Elimination: In most cases, the preferred approach is to eliminate the source of hazardous noise.

Substitution: When elimination is not possible, the substitution of loud equipment for quieter equipment may be the next best alternative to protect workers from hazardous noise.

Administrative Controls: Engineering control is not possible to remove the hazard through the use of administrative controls. Employers may change an employee's work schedule to avoid too much noise.

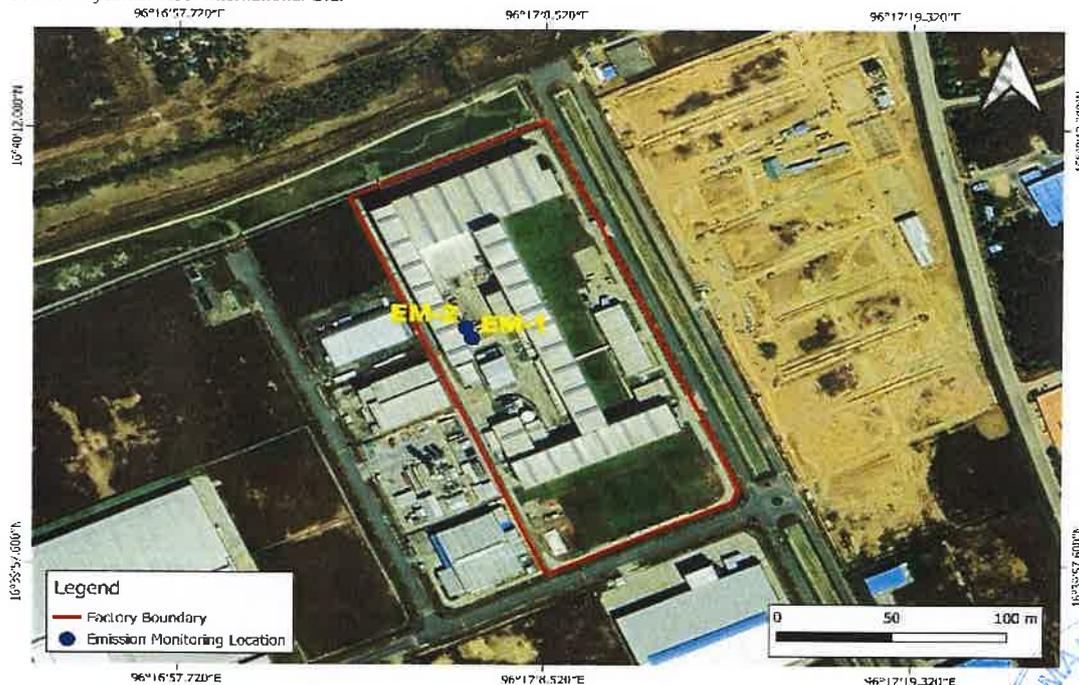
Figure 2.5-1 Location of Emission Monitoring Point

The emission monitoring measurement equipment, "PG-350 Horiba Portable Gas Analyzer" was set up at Regenerative Thermal Oxidizer (RTO) Stack and Chemical Drier Stack. The detail location of emission monitoring points is described in Table 2.5-2 and the location of emission monitoring points are shown in the Figure 2.5-1.

Survey Point	Coordinates	Description of Survey Point
EM-1	16°40'5.04"N, 96°17'6.35"E	Regenerative Thermal Oxidizer (RTO) Stack
EM-2	16°40'5.39"N, 96°17'6.17"E	Chemical Drier Stack

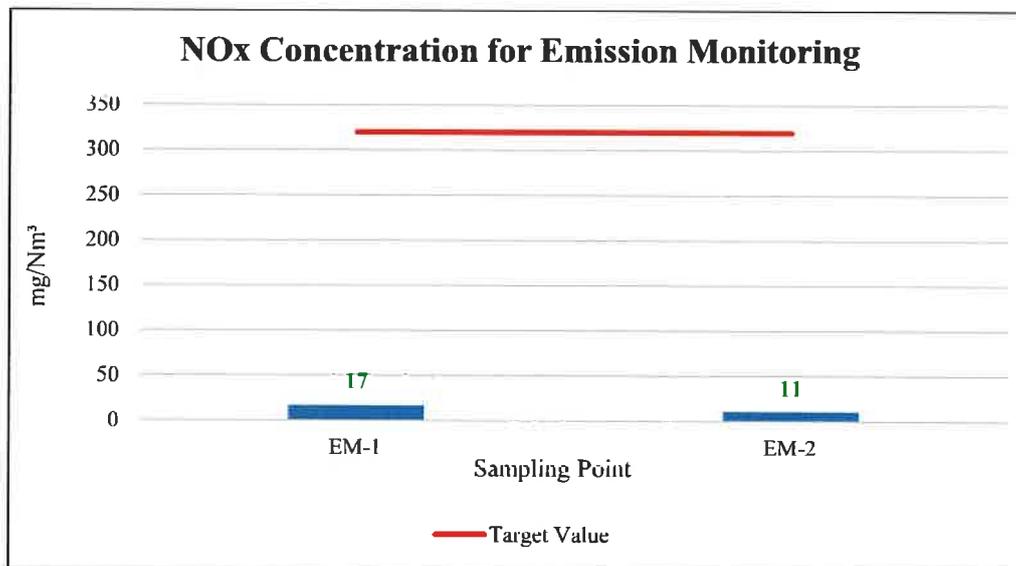
Figure 2.5-4 Results of Emission Monitoring

- 1) The value of NO_x is one hour average. All results are lower than the guideline value.
 - 2) The value of NO_x was converted to mg/Nm³ from ppm.
 - 3) The target value is referenced to the Final EIA report for JFE MYANMAR Coated Steel Co., Ltd.
- Source: Myanmar Koei International Ltd.
