**ENVIRONMENTAL QUALITY MONITORING REPORT
FOR MANUFACTURING OF METALLIC COATED
STEEL STRIP AND PAINTED STEEL STRIP OF
JFE MYANMAR COATED STEEL CO., LTD.
IN THILAWA SPECIAL ECONOMIC ZONE B
(OPERATION STAGE)**

July 2025

Myanmar Koei International Ltd.

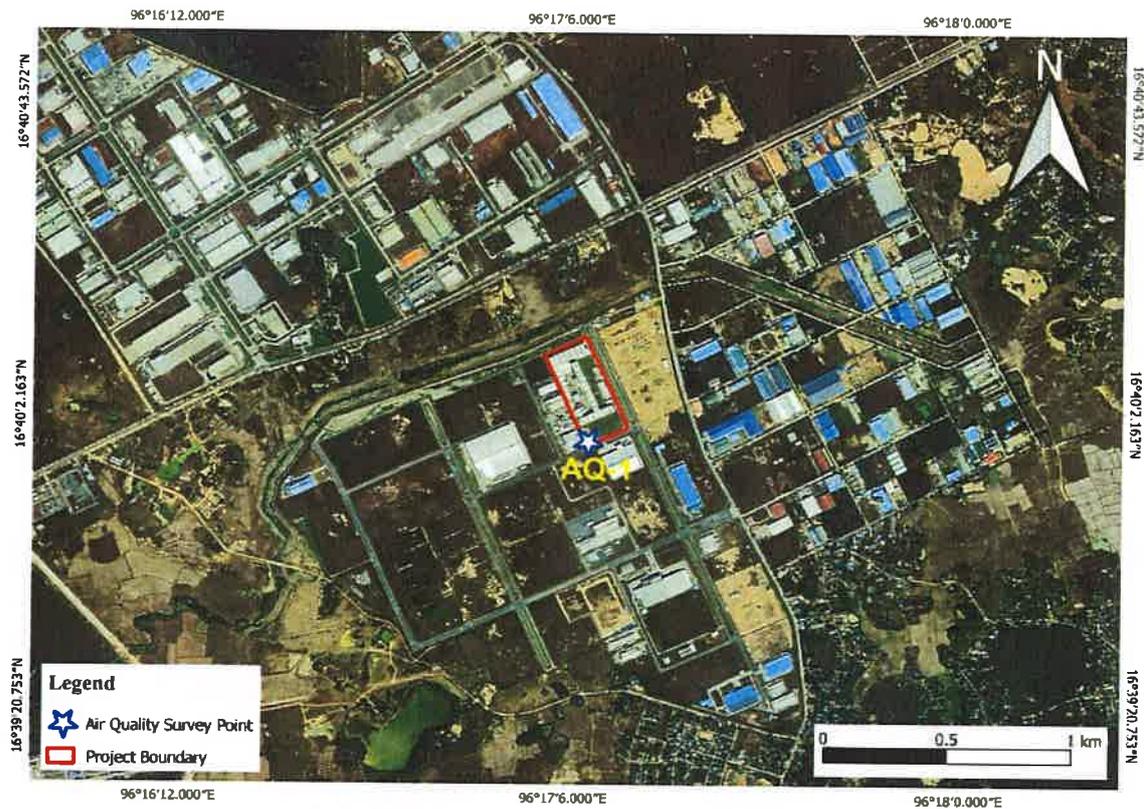
Figure 2.1-1 Location of Ambient Air Quality Monitoring Point

AQ-1 is located south corner inside of the JFE MYANMAR Coated Steel factory compound, which is nearest place to the sensitive receptors. The surrounding area are SIAM GS Battery Myanmar Ltd. in the southwest, RK Yangon Steel factory in the southeast, vacant lands and Thilawa Development Road in the east and northeast, Phalan monastery and Phalan village in the south.

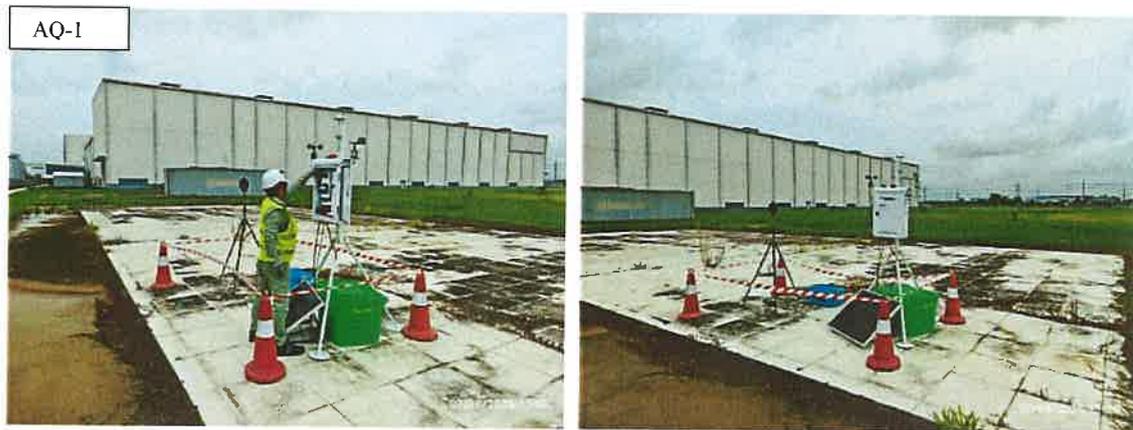
Figure 2.1-2 Status of Ambient Air Quality Monitoring Point at AQ-1

Survey of meteorology and ambient air quality (CO, CO₂, NO₂, PM_{2.5}, PM₁₀, Ozone and SO₂) were conducted by referring to the recommendation of the United States Environmental Protection Agency (U.S. EPA). The Oceanus AQM-09 Air Quality Monitoring System was used to collect ambient air pollutants. The system measures automatically every one minute and directly reads and records onsite for CO, CO₂, NO₂, PM_{2.5}, PM₁₀, Ozone and SO₂. Wind data are analyzed by using the WRPLOT View (Ver. 8.0.2), in which calm wind is defined below 0.5 m/s in term of the classification stipulated by National Oceanic and Atmospheric Administration (USA). The equipment of meteorological and ambient air quality survey is shown in Figure 2.1-2.

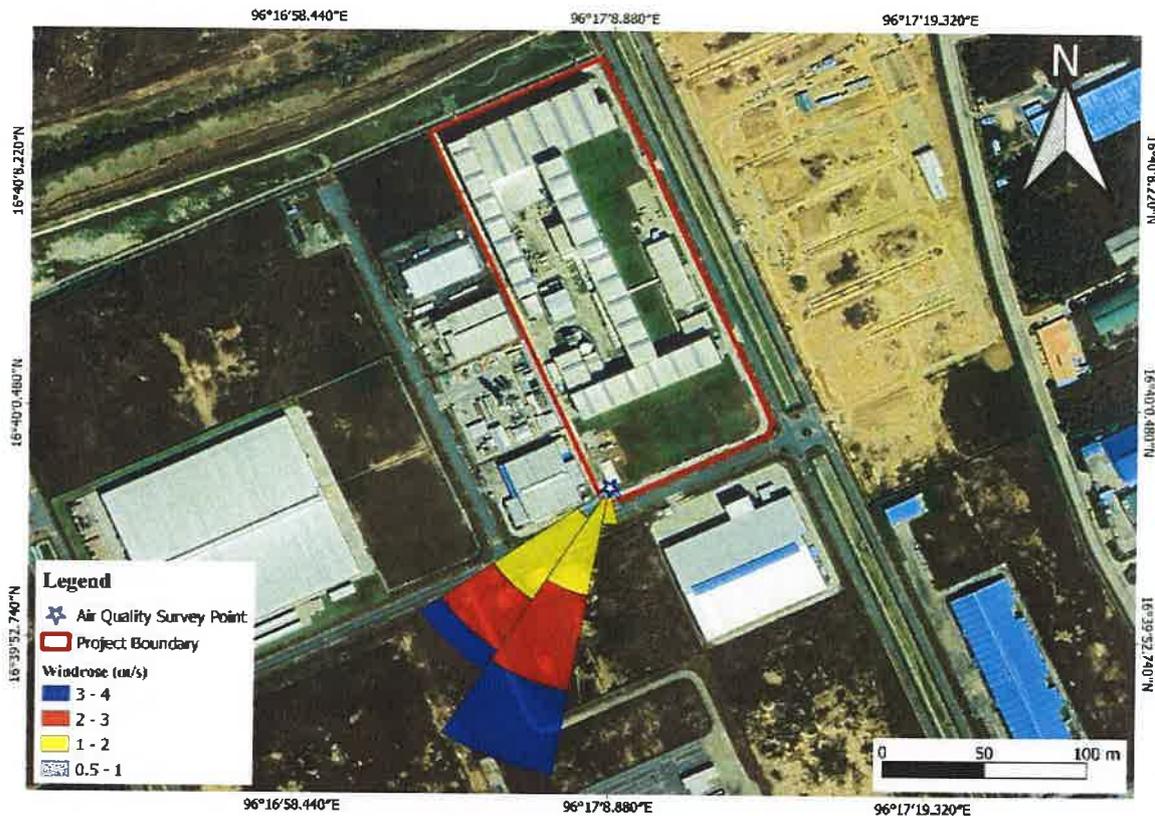
Figure 2.1-3 Wind Status at AQ-1

Wind direction and wind speed were measured at AQ-1. Hourly average values of measured wind direction and wind speed data are described in Appendix-1. Frequency of wind direction at AQ-1 and its wind rose diagram are described in Figure 2.1-3 and Figure 2.1-4. According to the wind rose analysis, the prevailing wind direction during monitoring was South-Southwest (SSW) and the least frequency wind direction was Southeast (SE). During the monitoring period, while the maximum wind speed was 3.93 m/s, the average speed is 1.98 m/s. No calm wind was recorded during monitoring, whereas the calm wind is defined below 0.5 m/s. As the average wind speed is higher than the defined calm wind, it is assumed that the wind was light air during the monitoring period.

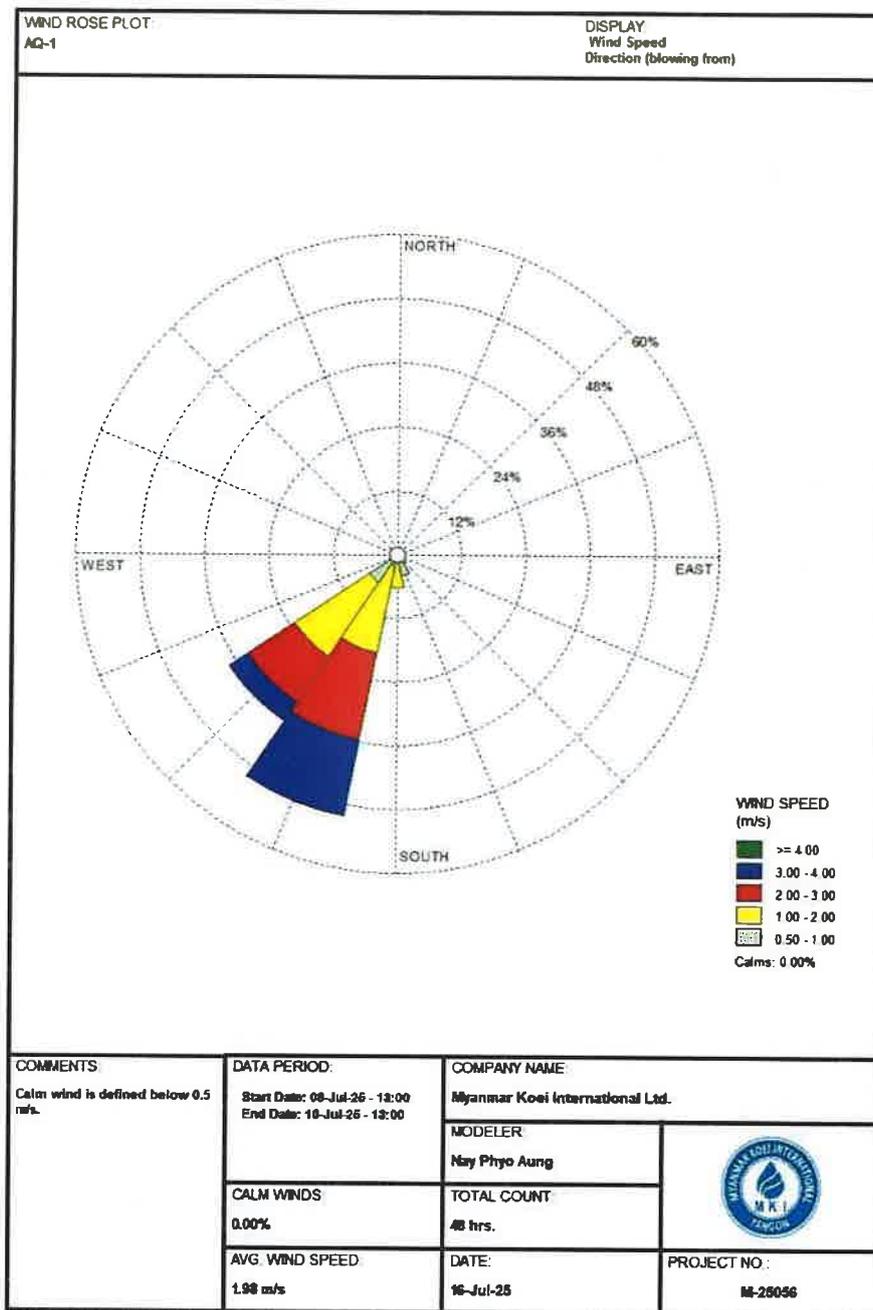
Figure 2.1-4 Wind Rose Diagram of AQ-1

According to the summary of wind direction at AQ-1, most of the prominent wind were blowing from Southwest (SW) quadrants.

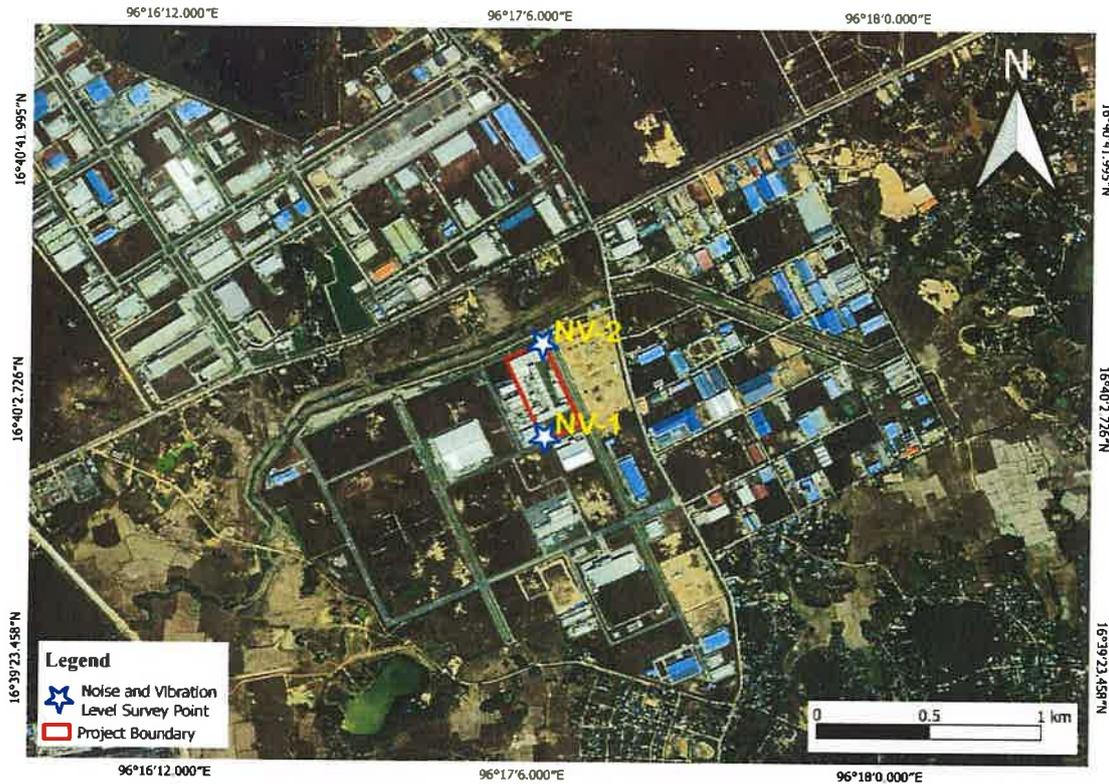
Figure 2.2-1 Location of Boundary Noise and Vibration Level Monitoring Point

The survey of Boundary noise and vibration level at NV-1 was conducted within the JFE MYANMAR Coated Steel factory compound. Boundary noise and vibration level monitoring was conducted 48 hours for survey point to know the boundary noise and vibration level near the JFE MYANMAR Coated Steel factory. Table 2.2-1 shows the outline of the boundary noise and vibration level monitoring.

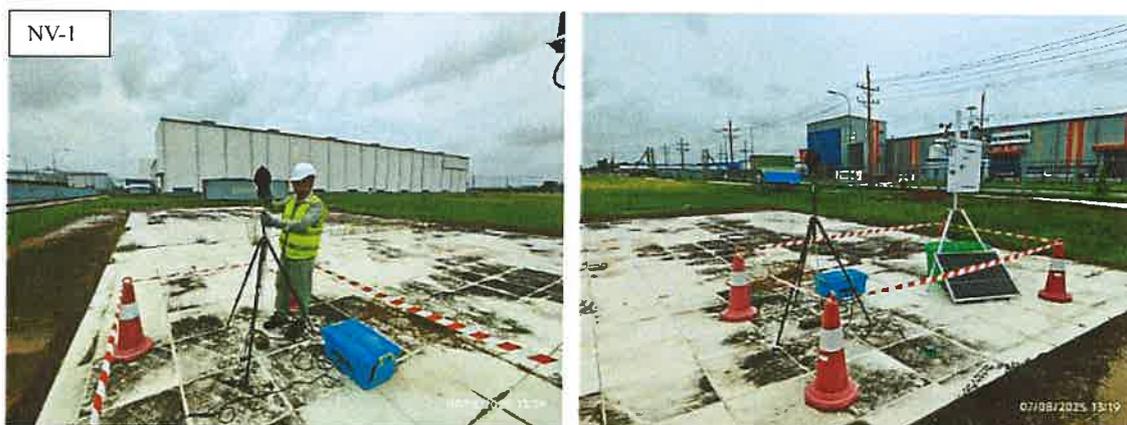
Figure 2.2-2 Status of Boundary Noise and Vibration Level Monitoring at NV-1

Boundary noise levels were measured by “Rion NL-42 and NL-43 sound level meters” and automatically recorded every 10 minutes on a memory card. The boundary vibration level meters, VM-53A and VM-55 (Rion Co. Ltd., Japan), accompanied by a 3-axis accelerometer PV-83C (Rion Co. Ltd.), were placed on solid soil ground. Vertical vibration (Z axis), L_{v10} , was measured every 10 minutes within the adaptable range of (10-70) dB at NV-1 and NV-2 recorded on a memory card. The measurement period of boundary noise and vibration was 48 hours for each survey point. The status of the noise and vibration level monitoring on NV-1 and NV-2 are shown in Figure 2.2-2 and Figure 2.2-3.

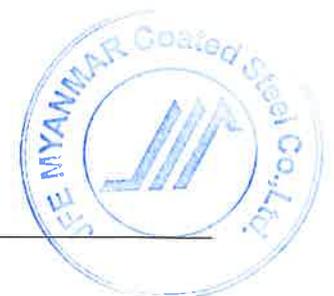
Figure 2.3-1 Location of Indoor Air Quality Monitoring Point

Survey Point	Coordinates	Description of Monitoring Point
Indoor Air Quality	16°40'4.49"N, 96°17'6.22"E	Two locations, Coater-A and Coater-B inside the compound of JFE MYANMAR Coated Steel factory.

IAQ-1 is located outside the Coater A room in the Continuous Paint Line (CPL) building of JFE MYANMAR Coated Steel factory, and it is located near to the walkway platform.

IAQ-2 is located outside the Coater B room in the Continuous Paint Line (CPL) building of JFE MYANMAR Coated Steel factory, and it is located near to the walkway platform.

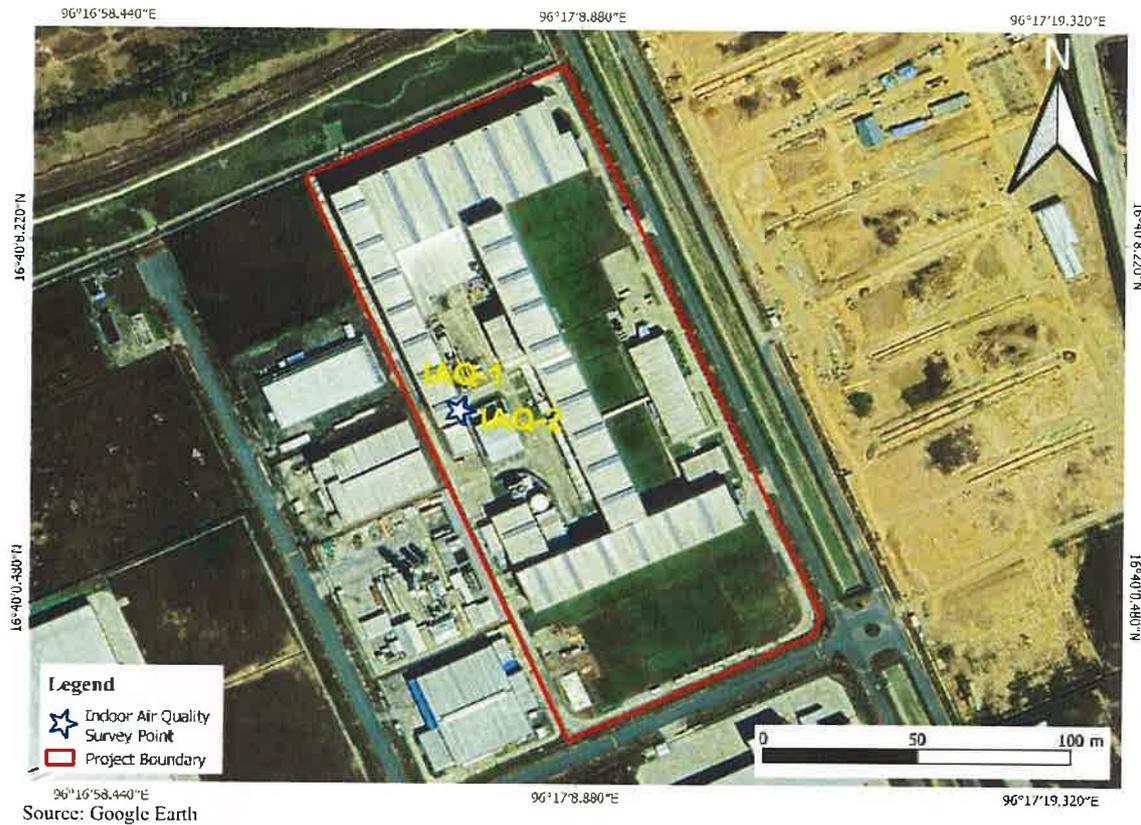
The survey of indoor air quality has been monitored at two locations, Coater-A and Coater-B inside the JFE MYANMAR Coated Steel factory. Indoor air quality has been conducted for one hour at each point to know the current indoor air quality of the JFE MYANMAR Coated Steel factory. Table 2.3-1 shows the outline of the indoor air quality monitoring.

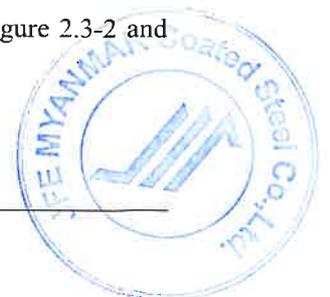
Figure 2.3-2 Status of Indoor Air Quality Monitoring at Coater-A

The status of indoor air quality monitoring for PM_{2.5}, PM₁₀ and VOC are shown in Figure 2.3-2 and Figure 2.3-3.

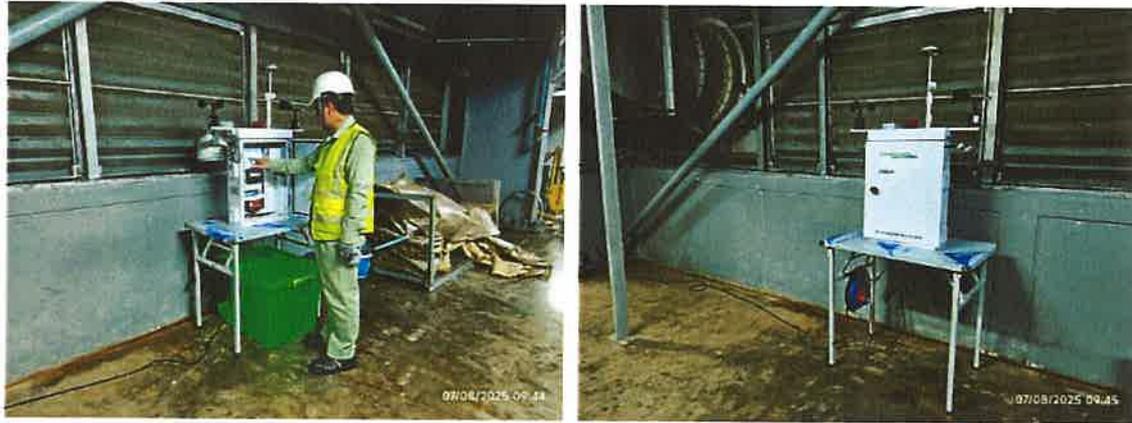
Survey of indoor air quality (PM_{2.5} and PM₁₀) was conducted by referring to the recommendation of the United States Environmental Protection Agency (U.S. EPA). Volatile organic compound (VOC) monitoring was carried out using a Photoionization Detector (PID) sensor, with a measurement range of 0–50 ppm, which was additionally installed in the AQM-09 Air Quality Monitoring System. The Oceanus AQM-09 Air Quality Monitoring System was used to collect indoor air pollutants. The system measures automatically every one minute and directly reads and records onsite for PM_{2.5} and PM₁₀.

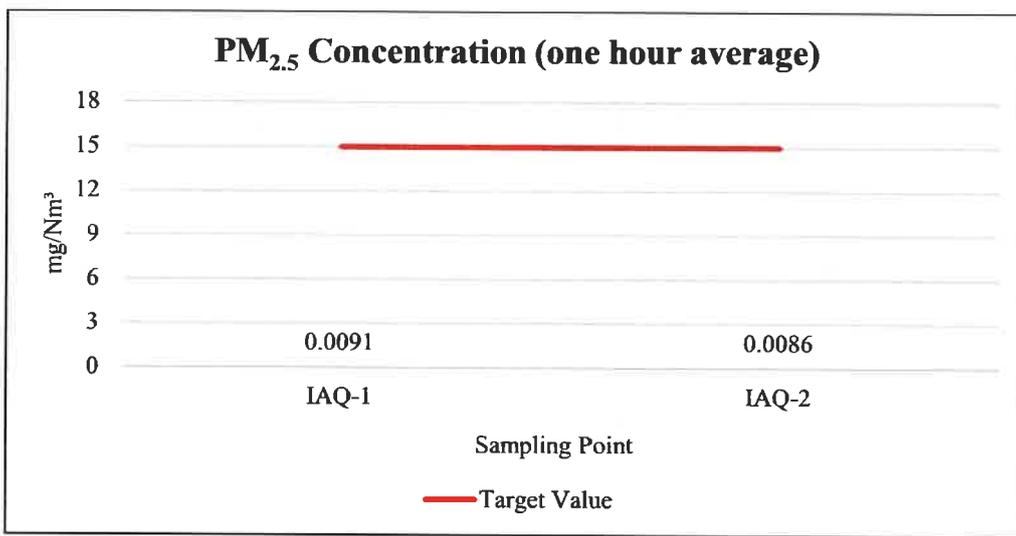
Figure 2.3-4 Results of Indoor Air Quality Monitoring (PM_{2.5})

The one-hour average value of indoor air quality monitoring results of $PM_{2.5}$, PM_{10} and VOC are described in Table 2.3-3. There is no guideline value for indoor air quality for $PM_{2.5}$ and PM_{10} in Myanmar's EQEG guideline. Therefore, the values of $PM_{2.5}$ and PM_{10} were compared with The National Institute for Occupational Safety and Health (NIOSH), Centers for Disease Control and Prevention (CDC), U.S. However, the value of VOC was compared with the final EIA report for JFE MYANMAR Coated Steel Co., Ltd. (referred to Section 2.2.1, (2) Air Emission Level, Table 2.2-4). The one hour average concentration of $PM_{2.5}$, PM_{10} and VOC were lower than the guideline value and the target value at Coater-A and Coater-B. Figure 2.3-4 to Figure 2.3-7 showed the results of $PM_{2.5}$, PM_{10} and VOC for indoor air quality monitoring.

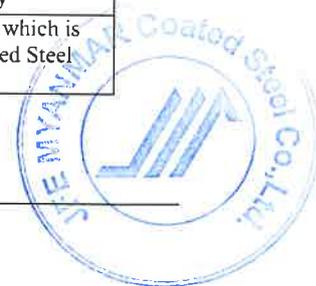
Figure 2.4-1 Location of Workplace Noise and Vibration Level Monitoring Points

Survey Point	Coordinates	Description of Monitoring Point
WNV-1	N: 16°40'4.50", E: 96° 17'6.14"	Near Coater-A which is inside the JFE MYANMAR Coated Steel factory
WNV-2	N: 16°40'7.17", E: 96° 17'4.90"	Entry Accumulator which is inside the JFE MYANMAR Coated Steel factory
WNV-3	N: 16°40'8.22", E: 96° 17'4.87"	Near Quality Control Laboratory which is inside the JFE MYANMAR Coated Steel factory

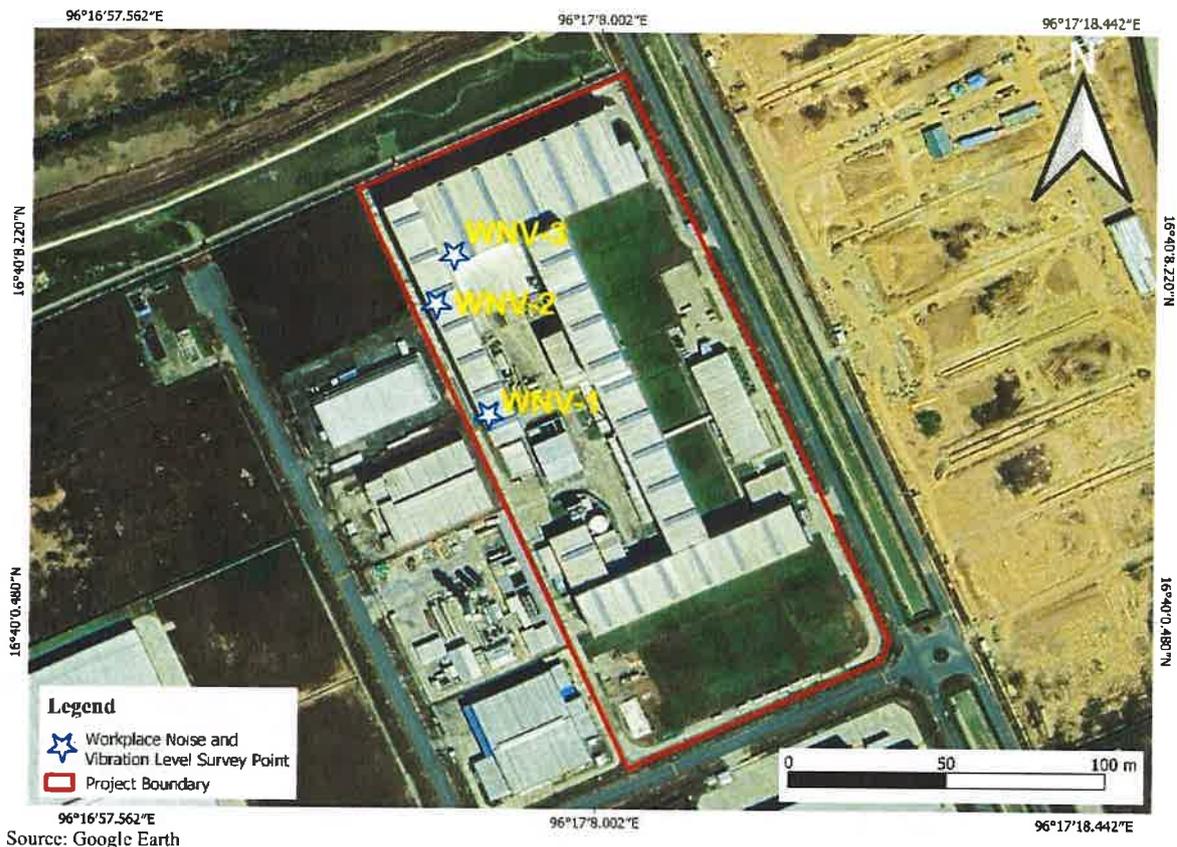
The survey of workplace noise and vibration level, WNV-1, WNV-2 and WNV-3, have been monitored inside the JFE MYANMAR Coated Steel factory which is the nearest place to near coater-A, entry accumulator and near quality control laboratory. Workplace noise and vibration level monitoring have been conducted one hour for each survey point to know the occupational noise and vibration level inside the JFE MYANMAR Coated Steel factory. Table 2.4-1 shows the outline of the workplace noise and vibration level monitoring.

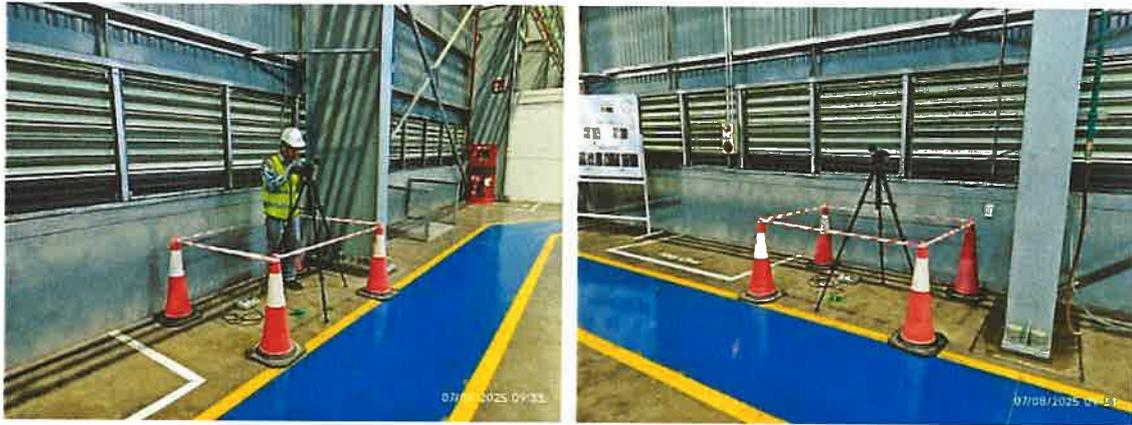
Figure 2.4-2 Status of Workplace Noise and Vibration Level Monitoring Near Coater-A

Workplace noise level was measured by “Rion NL-42 and NL-43 sound level meters” and automatically recorded every 10 minutes on a memory card. Workplace vibration level meter, VM-53A and VM-55 (Rion Co. Ltd., Japan), accompanied by a 3-axis accelerometer PV-83C (Rion Co. Ltd.), was placed on

solid soil ground. Vertical vibration (Z axis), L_{v10} , was measured every 10 minutes within the adaptable range of (10-70) dB at WNV-1, WNV-2 and WNV-3 recorded on a memory card.

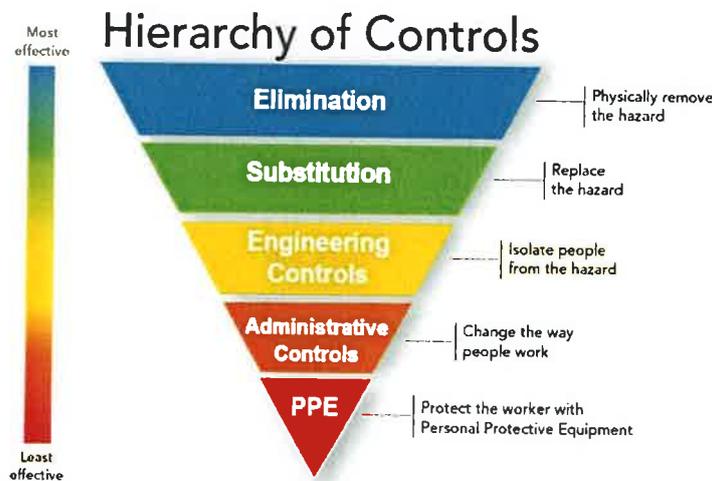
Figure 2.4-9 Hierarchy of Controls

The hierarchy of control can be used to determine how to implement feasible and effective controls. This approach groups actions by their likely effectiveness in reducing or removing the noise hazard.

Elimination: In most cases, the preferred approach is to eliminate the source of hazardous noise.

Substitution: When elimination is not possible, the substitution of loud equipment for quieter equipment may be the next best alternative to protect workers from hazardous noise.

Administrative Controls: Engineering control is not possible to remove the hazard through the use of administrative controls. Employers may change an employee's work schedule to avoid too much noise.

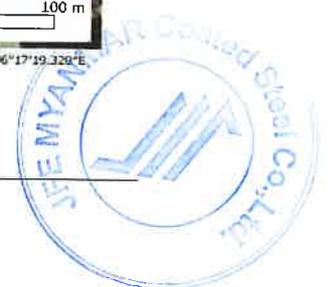
Figure 2.5-1 Location of Air Emission Monitoring Point

The air emission monitoring measurement equipment, "PG-350 Horiba Portable Gas Analyzer" was set up at Regenerative Thermal Oxidizer (RTO) Stack and Chemical Drier Stack. The detail location of air emission monitoring points is described in Table 2.5-2 and the location of air emission monitoring points are shown in the Figure 2.5-1.

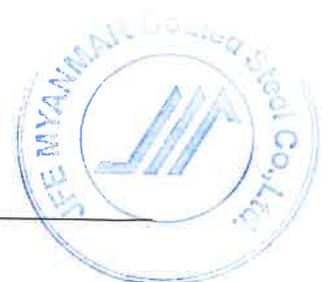
Figure 2.6-1 Location of Heat Stress Measurement Points

Survey Point	Coordinates	Description of Survey Point
H-1	16°40'10.59"N, 96°17'7.25"E	FC (Storage)
H-2	16°40'9.45"N, 96°17'4.37"E	FC (Packaging)
H-3	16°40'7.84"N, 96°17'5.71"E	Workshop
H-4	16°40'6.11"N, 96°17'5.05"E	CPL(GF)
H-5	16°40'6.20"N, 96°17'5.26"E	CPL (2 nd F)
H-6	16°40'6.13"N, 96°17'5.79"E	RTO
H-7	16°40'1.74"N, 96°17'7.61"E	Roll Shop
H-8	16°40'1.99"N, 96°17'11.18"E	CRC

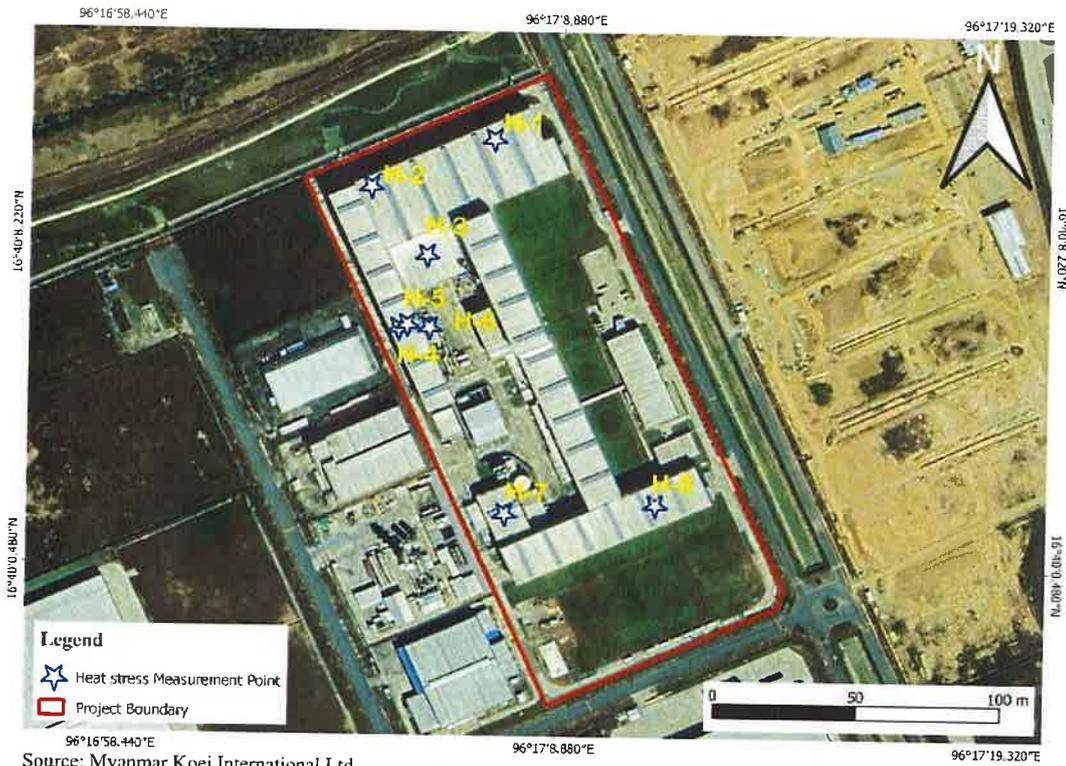
The parameters for heat stress measurement were Wet Bulb Globe Temperature (WGBT), Temperature (TA), Globe Temperature (TG) and Relative Humidity (RH).

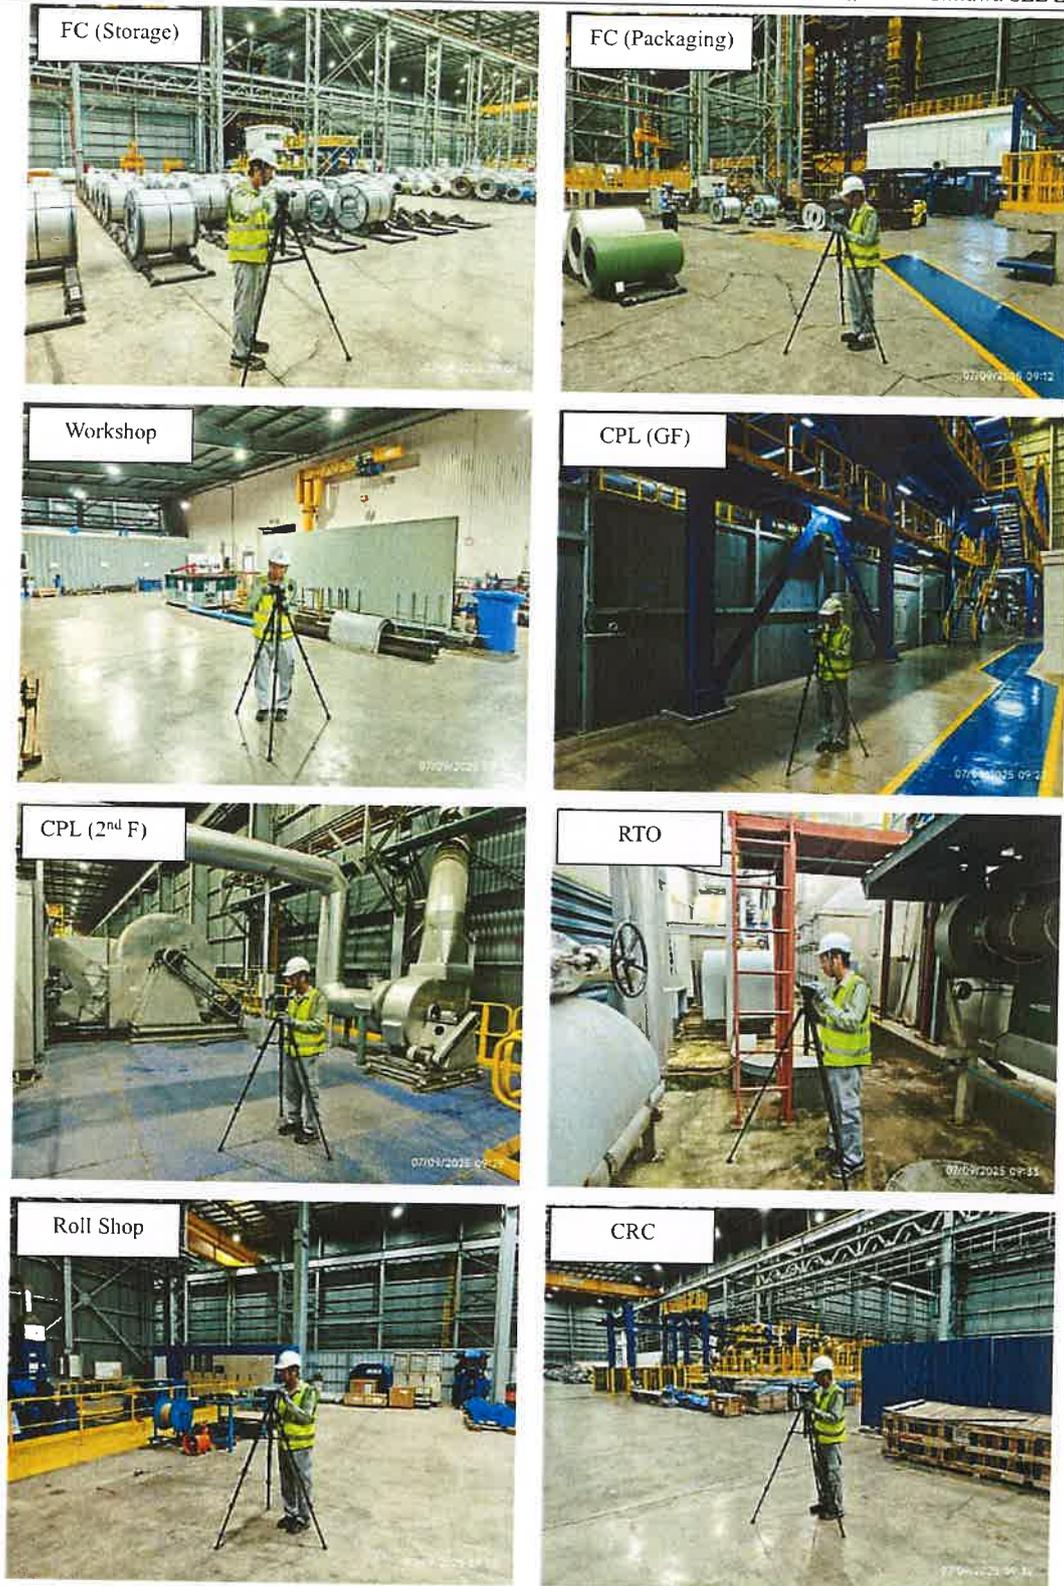
Figure 2.6-2 Location of Heat Stress Measurement Point

Heat stress measurement was conducted using the SATO SK-150GT, which can measure globe temperature (TG), air temperature (TA), and relative humidity (RH) at the same time. From the measured values, this instrument can calculate the WBGT index, which is used as a preventive measure for heat stress. The device was set up at an appropriate height in a representative work area. Measurements were taken at regular intervals after the instrument was stabilized. Recorded values were compared with WBGT range of specified heat stress risks. The status of heat stress measurement is shown in Figure 2.6-2.

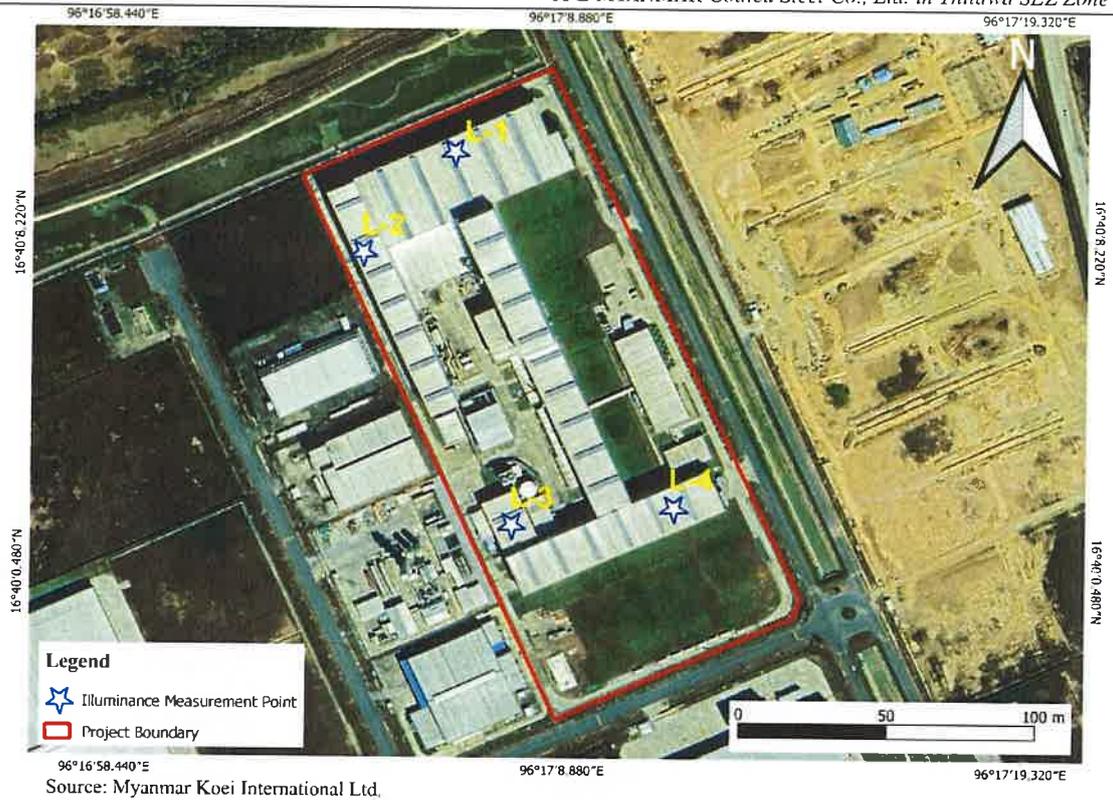
Figure 2.7-1 Location of Illuminance Measurement Point

The survey of illuminance measurement has been conducted inside JFE MYANMAR Coated Steel factory to know the current illuminance (light intensity) of the working area. Table 2.7-1 shows the outline of the illuminance measurement.

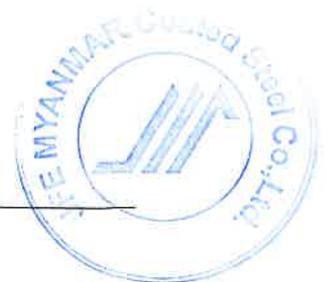
Figure 2.7-2 Location of Illuminance Measurement Point

Survey of illuminance measurement was conducted using the HOIKI FT3424 Lux Meter to assess the lighting conditions in the working environment. The device was mounted on a tripod at an appropriate height corresponding to the typical working area, and the sensor was oriented horizontally facing upward at each measurement point, avoiding any direct shading or reflection. Readings were recorded under normal operational lighting conditions, and the measured values were compared with minimum limit for illuminance levels mentioned in IFC EHS General Guidelines (2007). The status of illuminance measurement is shown in Figure 2.7-2.
